## Installation Manual BMW X5 E53 Repair Kit - Front Drive Shaft

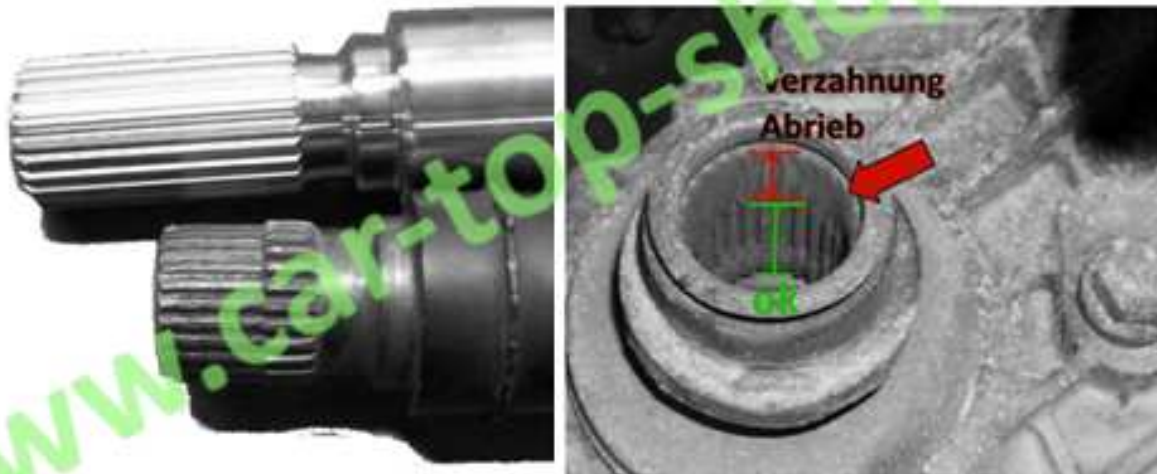
Here we offer a perfect and affordable solution to repair the vehicle quickly and in time. This is possible because the length of the teeth in the transfer case is much longer than the teeth of the original drive shaft. Therefore, you can extend this with our repair shaft.

In the BMW X5 E53 models, the transfer case is connected to the front differential (front differential) via a drive shaft (Jockey shaft / Kadan shaft). The problem in the drive shaft is the toothed end. Over the years, the teeth are used and thus ruined the teeth in the transfer case. It is therefore necessary to replace both the shaft and the transfer case, with repair costs of several thousand EUR/USD.

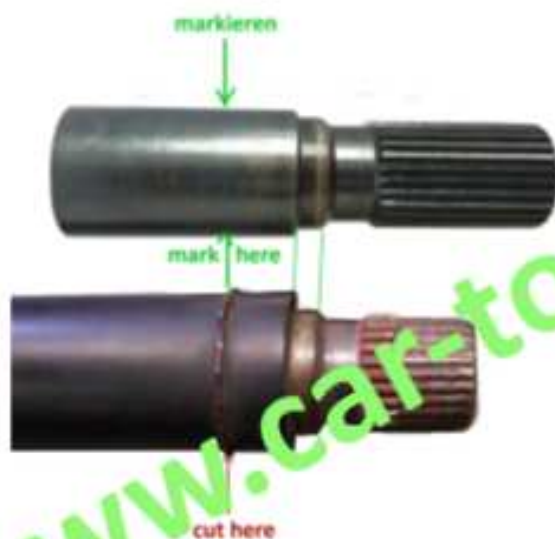
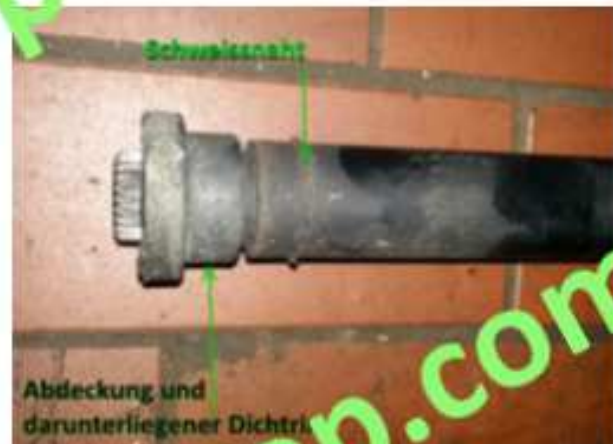
The teeth part must be cut off from the shaft at the original weld.

Before one begins with the split off, one must, however, draw the exact position of the interface on the new repair shaft. As a result, we know then how far the repair shaft must be inserted into the original drive shaft, so that afterwards the sealing ring is again at the original location exactly on the housing of the transfer case.

After you have cut off the teeth part approximately at the position of the old weld, you can put the repair shaft in the drive shaft to the previously marked position.

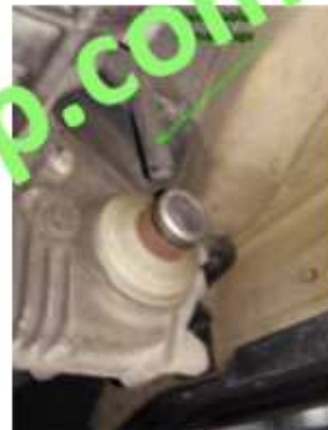
Maybe you should give the drain hose of the climate a little to the side so that the condensation does not drip directly on the shaft.
